Health monitoring of an Oregon historical bridge with fiber grating strain sensors

ABSTRACT

Twenty-eight fiber-grating sensors were used to instrument two reinforced concrete beams that were externally strengthened with composites on the historic Horsetail Falls Bridge in the Columbia River Gorge. Sensor assemblies were placed in the beams and mounted on the outside of the composite to provide performance data.

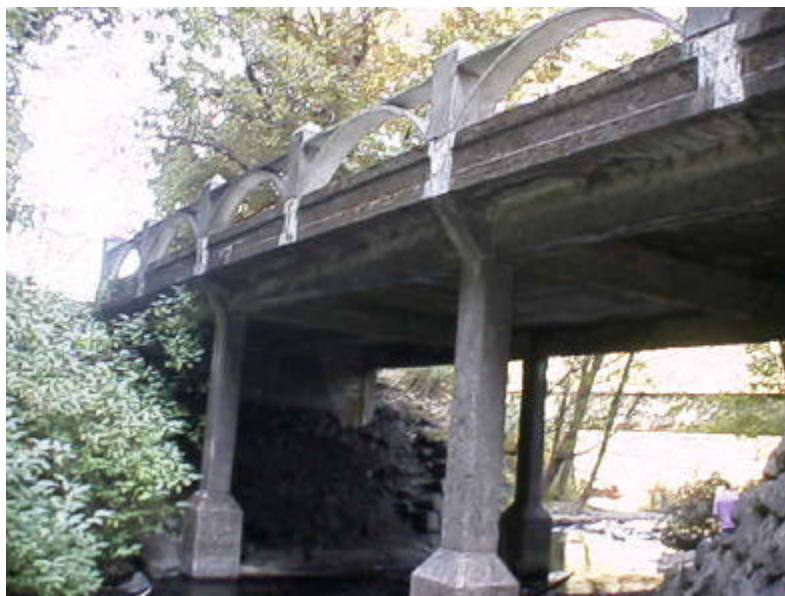
The historic Horsetail Falls Bridge (figure 1) is a 60-foot reinforced concrete slab span type, consisting of three 20-foot spans. The structure, built in 1914, is located on Crown Point Highway 125 at mile point 22.2, approximately 30 miles east of Portland, Oregon.

Figure 1: Horsetail Falls Bridge before the strengthening composite wrap was installed.

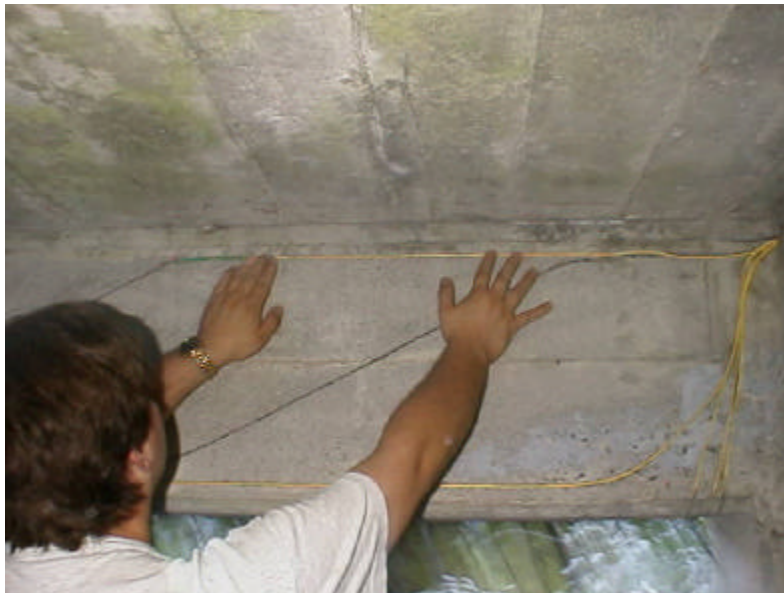
Several innovations were demonstrated in the design of the sensors for the bridge. Very small flexible tubing was used to support and protect the Bragg gratings while being placed into small grooves (figure 2) in the concrete beams as well as directly onto the composite. Small size was important to avoid altering the appearance of the bridge while allowing both the concrete beam and composite to be independently monitored.

Figure 2: Installation of long gauge length bragg grating sensors into a beam.

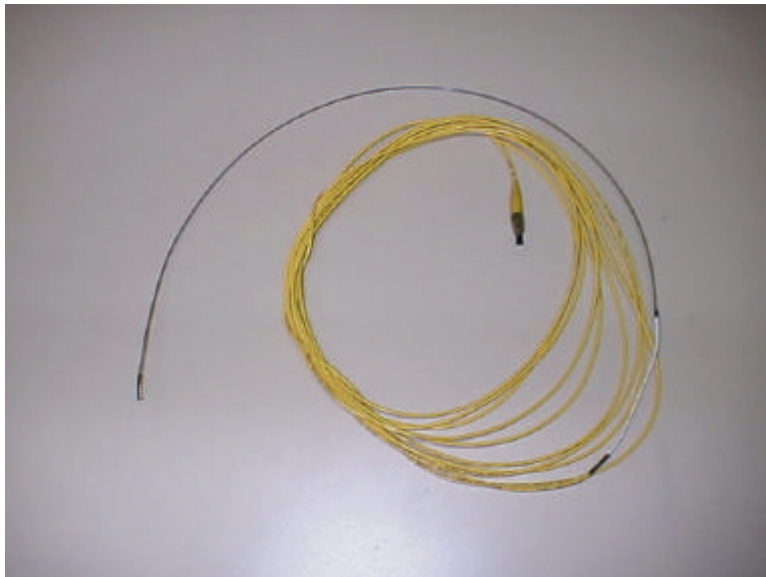
The actual gratings have a gauge length on the order of a centimeter. Sensors with an effective gauge length of 70cm and 100cm long were desired. The fiber Bragg gratings were mounted in capillary tubes, cut to 70cm and 100cm lengths, with an outer diameter of 1.6mm and inner diameter of 250 μ . The tubing is made of a polymer called PEEK, poly-ether-ether-keytone. During fabrication the grating was placed approximately in the center of the tube and epoxied at one end. When the epoxy was cured, a known mass was attached to the opposite end so as to pre-strain the Bragg grating by approximately 1000 μ strain. After the free end of the grating was epoxied to the tube, the fiber was then spliced to a rugged simplex single-mode patch cord. Shrink tube and splice protectors were used to cover any bare fiber. A picture of one sensor is shown in figure 3.

Figure 3: A 70cm gauge length fiber optic strain sensor and cable.

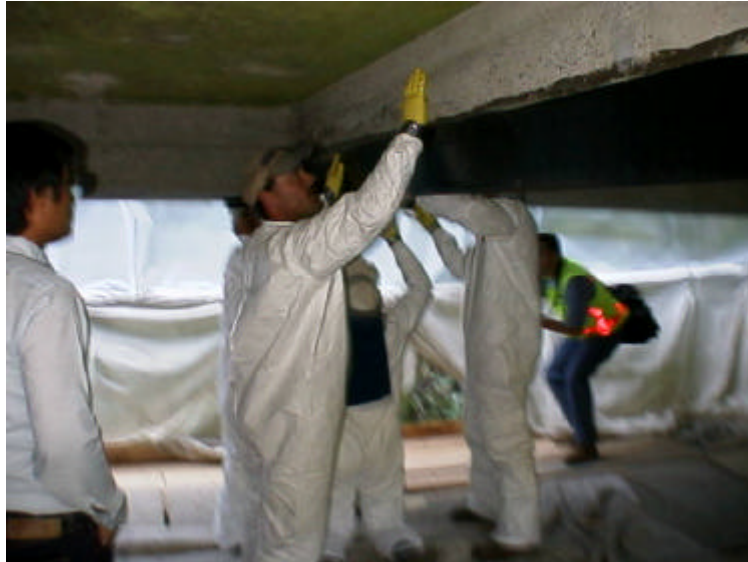
Carbon fiber sheets impregnated with resin were then adhered to the bottom and the lower part of the sides of all transverse beams on the structure for flexural control (shown in figure 4).

Figure 4: Installation of the Carbon-Epoxy Strengthening Material.

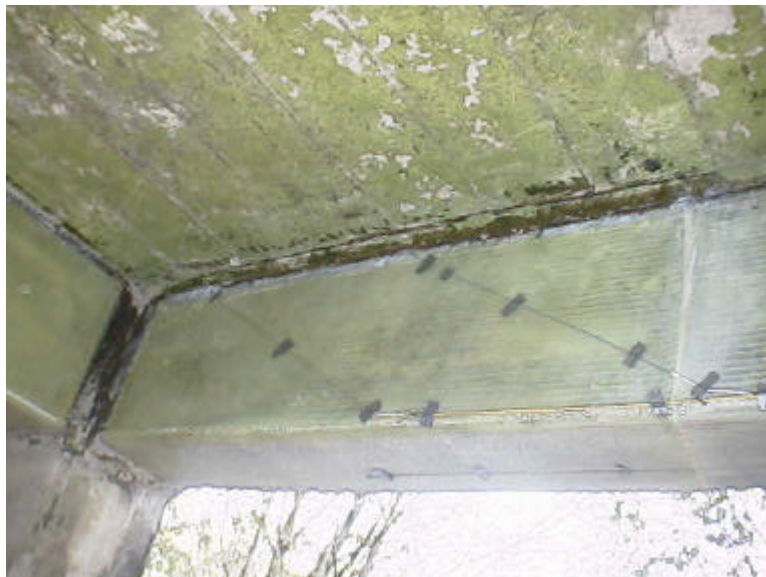
Impregnated Glass-epoxy sheets were placed over all of the beams for shear control. Once the glass-epoxy material had cured sufficiently, another set of 14 sensors were mounted on the outside of the two test beams with a fast curing epoxy (see figure 5). Sensor placement, gauge length, and number of

Figure 5: Sensors were mounted onto the glass-epoxy material after curing sufficiently.

sensors were identical to the set embedded in concrete. A special epoxy cosmetic coat (figure 6) was placed over the composite and sensors so that the appearance of the beams would closely match the appearance of the original concrete.

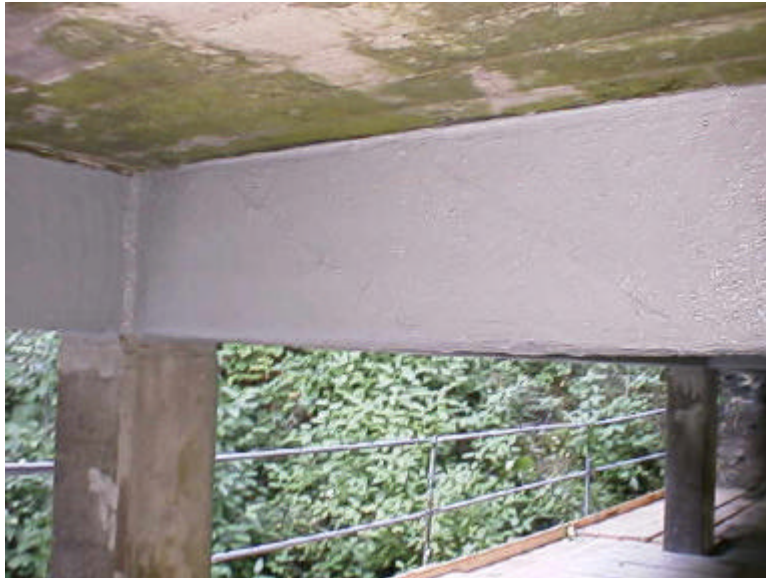
Figure 6: A cosmetic coat of epoxy was applied to the composites.

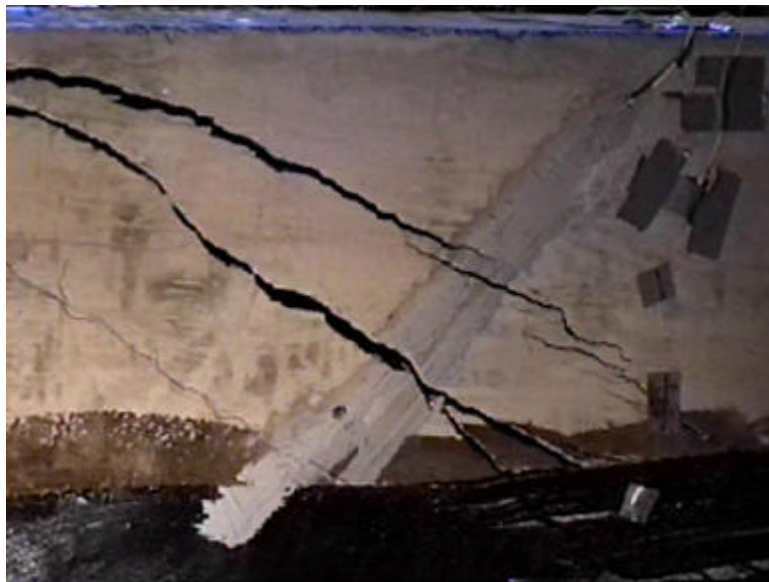
More extensive laboratory tests on full-scale model beams are scheduled. The beams have been outfitted with sensors and composite wraps identical to what was done on the Horsetail Falls Bridge for model verification. As of this writing, the control beam and one of the three test beams have been loaded to failure (figure 7) . The sensors were installed across the likely failure points – in this case the shear zone.

Figure 7: Shear failure in a full scale model concrete beam based on the Horsetail Falls Bridge beams.

The black material at the bottom of figure 7 is the carbon FRP used to strengthen the beam in flexure. The light gray lines perpendicular to the major cracks were fiber sensors placed to measure shear. These two sensors did not survive the beam failure. This reinforced beam failed under a 155 kpsi load while the control beam failed after 105 kpsi was applied.
