COMPOSITE STRENGTHENING AND INSTRUMENTATION OF THE HORSETAIL FALLS BRIDGE WITH LONG GAUGE LENGTH FIBER BRAGG GRATING STRAIN SENSORS

JOHN SEIM, ERIC UDD, WHITTEN SCHULZ
BLUE ROAD RESEARCH
2555 NE 205TH AVENUE, FAIRVIEW, OREGON, 97024 USA
PH: 503-667-7772; FAX: 503-667-7880

HAROLD M. LAYLOR
OREGON DEPARTMENT OF TRANSPORTATION
200 HAWTHORNE SE, SUITE B-240, SALEM, OREGON, 97310 USA
PH: 503-986-2850; FAX: 503-986-2844

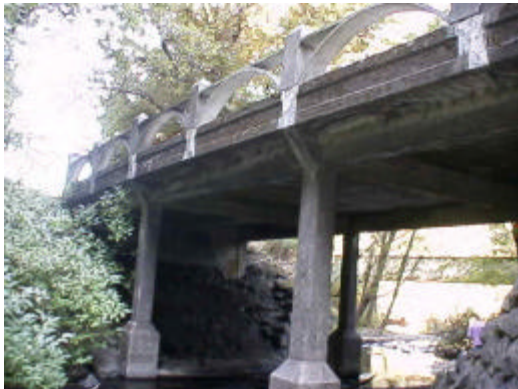
Figure 1: Horsetail Falls Bridge.

The historic Horsetail Falls Bridge (figure 1) is a 60-foot reinforced concrete slab span type, consisting of three 20-foot spans. The structure, built in 1914, is located on Crown Point Highway 125 at mile point 22.2, approximately 30 miles east of Portland, Oregon.

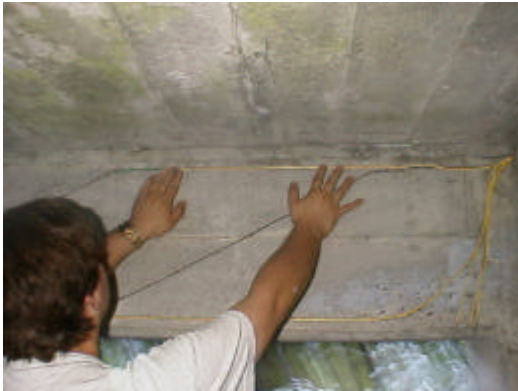
Figure 2: Installation of Long Gauge Length Bragg Grating Sensors into a Beam.

Several innovations were demonstrated in the design of the sensors for the bridge. Very small flexible tubing was used to support and protect the Bragg gratings while being placed into small grooves (figure 2) in the concrete beams as well as directly onto the composite. Small size was important to avoid altering the appearance of the bridge while allowing both the concrete beam and composite to be independently monitored.

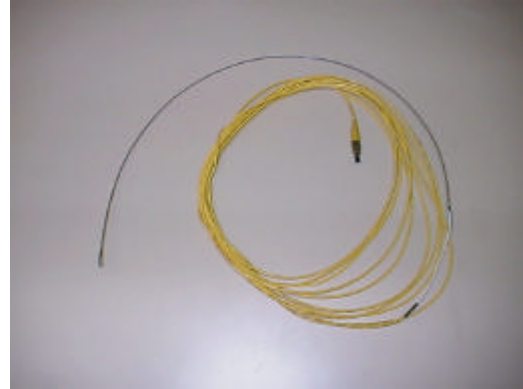
Figure 3: A 70cm Gauge Length Fiber Optic Strain Sensor and Cable.

The actual gratings have a gauge length on the order of a centimeter. Sensors with an effective gauge length of 70cm and 100cm long were desired. The fiber Bragg gratings were mounted in a capillary tubes, cut to 70cm and 100cm lengths, with an outer diameter of 1.6mm and inner diameter of 250 μ . The tubing is made of a polymer called PEEK, poly-ether-ether-keytone. During fabrication the grating was placed approximately in the center of the tube and epoxied at one end. When the epoxy was cured, a known mass was attached to the opposite end so as to pre-strain the Bragg grating by approximately 1000 μ strain. After the free end of the grating was epoxied to the tube, the fiber was then spliced to a rugged simplex single-mode patch cord. Shrink tube and splice protectors were used to cover any bare fiber. A picture of one sensor is shown in figure 3.

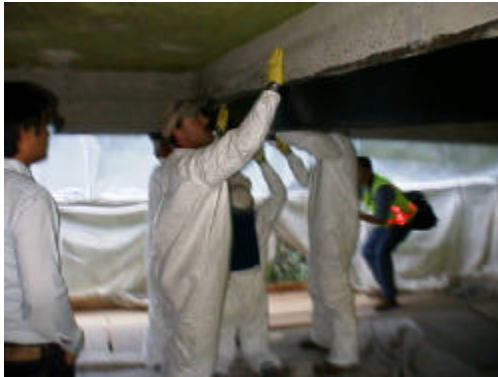
Figure 4: Installation of the Carbon-Epoxy Strengthening Material.

Carbon fiber sheets impregnated with resin were then adhered to the bottom and the lower part of the sides of all transverse beams on the structure for flexural control (shown in figure 4).

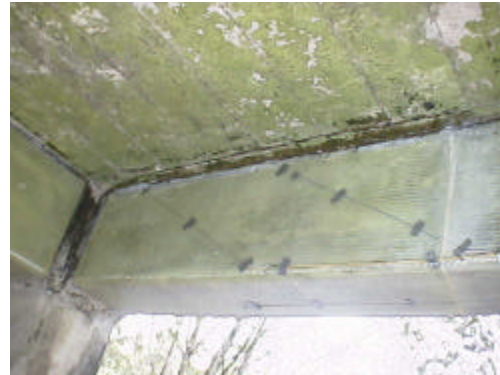
Figure 5: Sensors are Mounted onto the Glass-Epoxy Material after Curing Sufficiently.

Impregnated Glass-epoxy sheets were placed over all of the beams for shear control. Once the glass-epoxy material had cured sufficiently, another set of 14 sensors were mounted on the outside of the two test beams with a fast curing epoxy (see figure 5). Sensor placement, gauge length, and number of sensors were identical to the set embedded in concrete. A special epoxy cosmetic coat (figure 6) was placed over the composite and sensors so that the appearance of the beams would closely match the appearance of the original concrete.

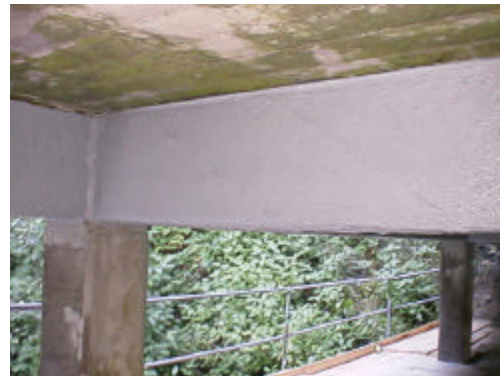
Figure 6: A Cosmetic Coat of Epoxy was Applied to the Composites.
