USAGE OF FIBER GRATING SENSORS TO PERFORM CRITICAL MEASUREMENTS OF CIVIL INFRASTRUCTURE

E. Udd, S. Calvert, and M.Kunzler
Blue Road Research
376 NE 219th Avenue, Gresham, Oregon 97030

Fiber optic grating sensors have been used to support long term health monitoring of the Horsetail Falls historic bridge in Oregon, traffic monitoring on the I-84 freeway, testing of large bridge structures and most recently preparations for instrumentation of a major bridge in Portland, Oregon. This paper overviews these efforts.

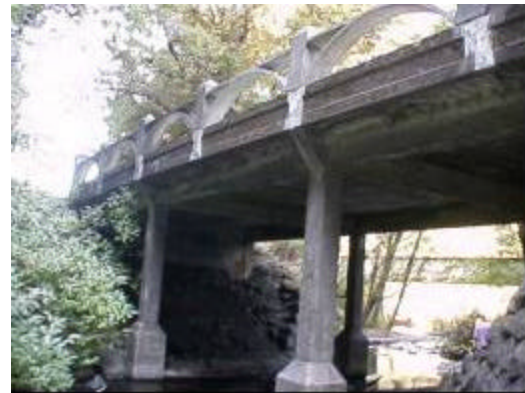
FIGURE 1. HORSETAIL FALLS BRIDGE

The first major civil structure installation of Blue Road Research was the Horsetails Falls Bridge in the Columbia River Gorge National Scenic Area located approximately 33 miles east of downtown Portland, Oregon [1-3]. This bridge, shown in Figure 1, is a historic bridge constructed in 1914 that was originally intended to support lightweight automobiles and horse carriages. Because it is located in the most heavily visited natural tourist area in Oregon the Oregon Department of Transportation sought means to strengthen the bridge to support tour buses while maintaining the appearance of the bridge in conformance with requirements of the Columbia River Gorge Commission. A composite over wrap method was selected and Blue Road Research produced approximately 60 long gage length fiber grating sensors that were placed in full scale test beams subject to break testing and 28 sensors in the Horsetail Falls bridge to measure both shear strain and tensile strain in key beam locations. The fiber grating sensors were placed both in the composite over wrap and in the concrete beams by cutting 3 mm grooves.

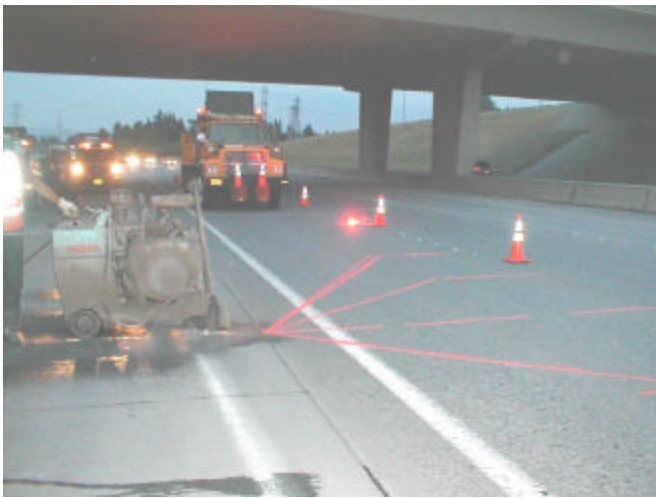
FIGURE 3. INSTALLATION OF FIBER GRATING SENSORS INTO THE I 84 FREEWAY

based devices to support monitoring vehicle speed and weigh in motion. There are difficulties installing these electrical sensors and they are prone to early failure. The piezoelectric based devices often give the highest accuracy but they are surface mounted and tire induced wear often severely limits their lifetime. What was needed was a system that could be placed approximately 7.5 cm under the freeway surface with sufficient sensitivity to identify traffic by axle counting, measure speed and eventually support weigh in motion. Blue Road Research with support from the Oregon Department of Transportation has installed two sets of four sensors each on the I 84 freeway [4-7]. The first set of fiber grating sensors was installed in August of 2001. Figure 3 shows cuts being made in the I 84 freeway to support the first set of fiber grating sensors.

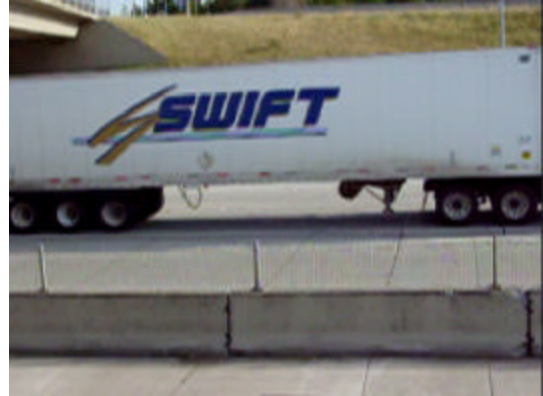
FIGURE 4. PHOTO OF TRUCK TRAILER PASSING OVER THE I 84 FREEWAY IN THE VICINITY OF THE FIBER GRATING STRAIN SENSORS, SEE FIGURE 4

As an example Figure 4 shows a truck trailer whose signature from two of the sensors in the I 84 freeway is shown in Figure 5. The truck trailer has two leading and three trailing axels. The separation in time between the leading edge events may be used to determine truck speed. The separation between peaks can be used to determine the axel separation that in turn may be used to identify the type of truck trailer being used.

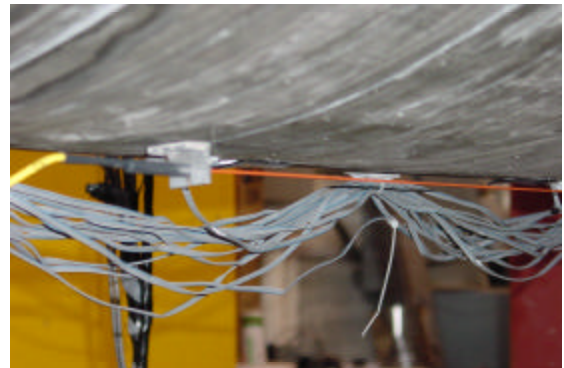
FIGURE 8. LONG GAGE LENGTH FIBER GRATING SENSOR MOUNTED ON THE BOTTOM OF THE BEAM

Figure 7 shows the experimental set up for four point bend testing. Long gage length fiber grating strain sensors as shown in Figure 8 were mounted on the girder along with accelerometers. A shaker shown in Figure 9 was used to activate the girder and generate modes of vibration. A large instrumented hammer was also used.
